# Chippewa River Watershed Monitoring Summary 2003

Chippewa River Watershed Project  
629 North 11th Street  
Montevideo, MN 56265  
320-269-2139 ext 119  
[www.chippewariver.com](http://www.chippewariver.com)

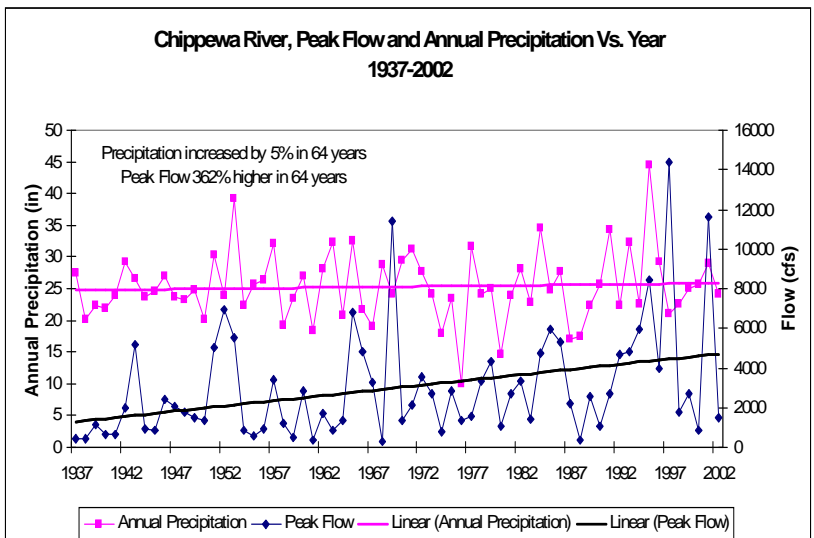
Chippewa River, Peak Flow and Annual Precipitation Vs. Year 1937-2002

At the Hwy 40 Chippewa River Mainstem site the USGS has been conducting the flow monitoring for 64 years. In this time they have documented a 350% increase in the annual high water level. The University of Minnesota Climatology Working Group has documented a 5 % increase in Rainfall over the same time. This suggests that there are other factors driving the increase in Peak flood events on the Chippewa River. Most likely human changes on the hydrology of the River have brought about the change. These include but are not limited to stream straightening , improvement of drainage, opening and drainage of previously closed systems, increased areas with impervious surfaces, removal of woodlands and grasslands.

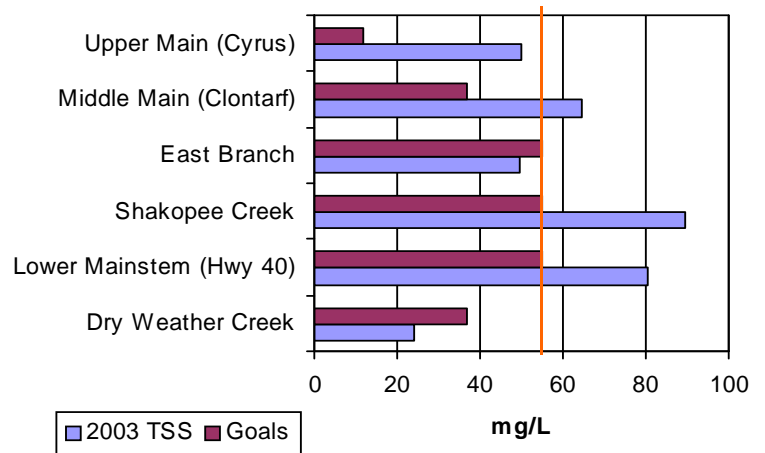
Total Suspended Solids, 2003

Flow weighted mean concentrations for 2003 were fairly close to 2002 concentrations. Overall we observed a continuation of the decreasing trend that has been observed over the last 4 years. One exception was observed to this trend. The Upper Mainstem, monitored at Site 2, Cyrus, over the past two years has exhibited much higher concentrations of TSS than in previous years.

While the decreasing TSS trend in 2003 is positive, most of the Chippewa sub-basins did not achieve their limited target goals that CRWP partners set for them in 1999. Shakopee Creek, the Upper Mainstem and the Middle Mainstem were the main contributors to the TSS being 47% over the target goal at Hwy 40. These concentrations will be hard to improve without cutting the upstream tributary concentrations and curbing peak flood events.

According to the Minnesota Pollution Control Agency, TSS concentrations of 58 through 66 mg/L can be used to list a river as impaired (red line on chart). The Lower Mainstem, Middle Mainstem and Shakopee Creek all had Flow Weighted mean concentrations exceeding this level.

Two basins deserve praise in 2003. The East Branch and Dry Weather Creek met their goal levels for TSS. This is the second year that they have achieved their goals.

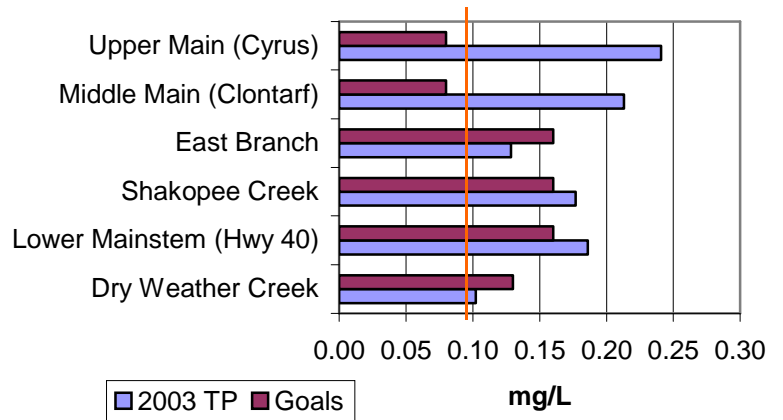
Total Phosphorous, 2003

Total phosphorous concentrations varied widely across the watershed (see chart at right). Two sub-basins, the East Branch and Dry Weather Creek achieved the goals that CRWP partners set for them in 1999. Furthermore, Dry Weather Creek almost achieved the 0.1 mg/L desired goal set by the Environmental Protection Agency for prevention of nuisance algal growth.

The Lower Mainstem and Shakopee Creek were both close to their goal concentrations. The Lower Mainstem was up 5% a statistically insignificant change. Shakopee Creek was down 27% over 2002 concentrations. This drop for Shakopee Creek is quite a jump

The Upper Main and Middle Main 2003 concentrations were the highest observed in 2003. They were also more than double their goal concentrations. The 2002 upper main flow weighted mean was 24% higher than 2002 and The 2003 Middle Main was 39% higher than 2002. This trend in the Chippewa River headwaters region is a growing concern and threatens to destabilize downstream efforts to bring phosphorous concentrations down
