Chippewa River Watershed Monitoring Summary 2005

Watching The Chippewa Wash Away One Day at a Time

Paul Wymar
Chippewa River Watershed Project
629 North 11th Street
Montevideo, MN 56265
320-269-2139 ext 119
www.chippewariver.com

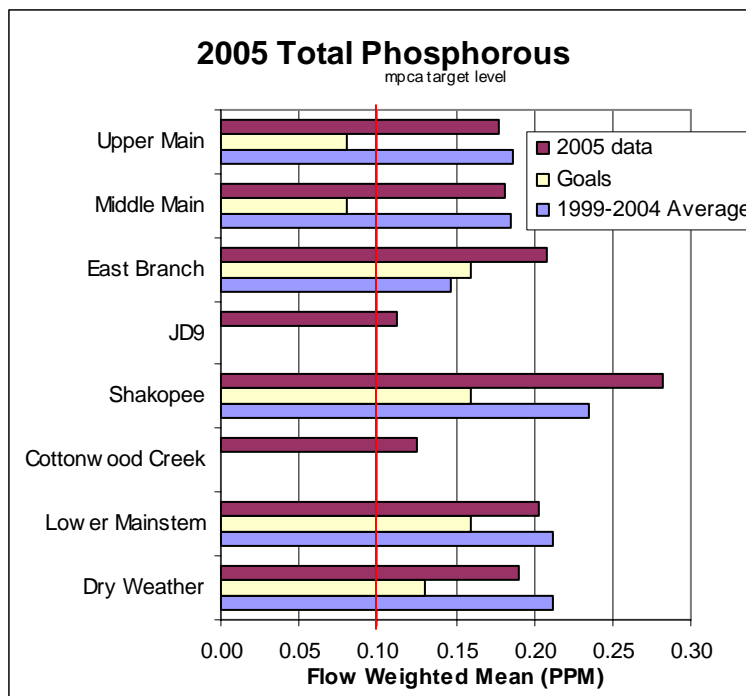
Total phosphorous (TP) concentrations were high across the watershed (see chart at right). No sub-basin achieved its goals. Neither were any sites below the 0.1 mg/L desired goal set by the Environmental Protection Agency for prevention of nuisance algal growth.

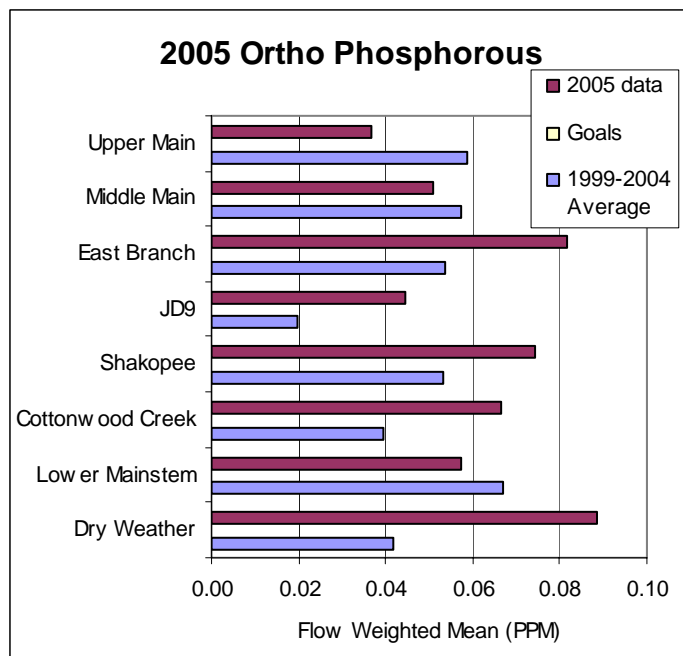
Orthophosphorous (OP) concentrations varied across the watershed (see red bars on the chart, at right). Concentrations did appear to follow a logical pattern as water flowed downstream and tributaries contributed waters with different concentrations.

Another way of looking at OP levels is to see how much of the Total Phosphorous (TP) concentration was accountable to OP. High portions of OP suggest either high levels of natural sources such as wetlands or high levels of chemical fertilization. The levels of OP were 20-30% of the TP level for the Upper and Middle Mainstem sub-basins. Whereas for the lower basins OP made up a much more sizable portion of TP, OP ran from 30-55% of TP. The highest OP concentration and portion was found in Cottonwood Creek which has very few wetlands and is over 95% farmed.

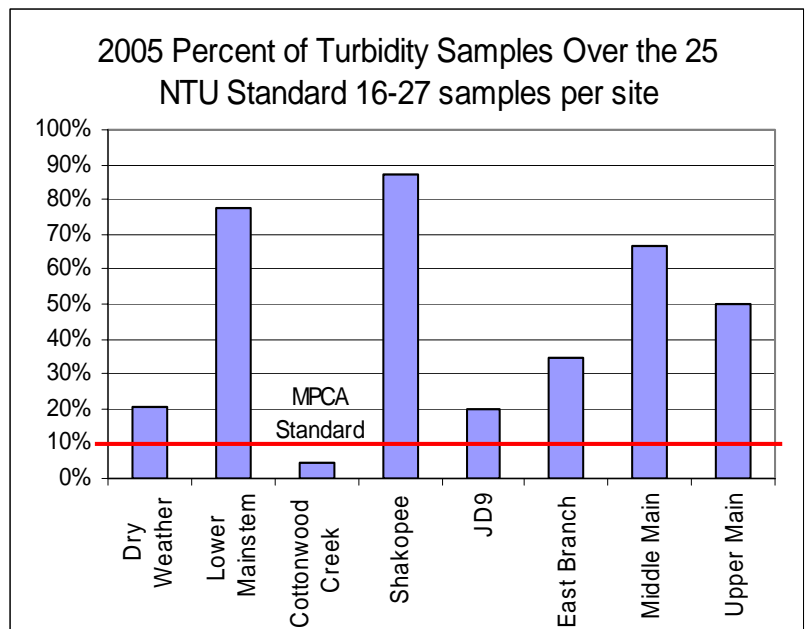
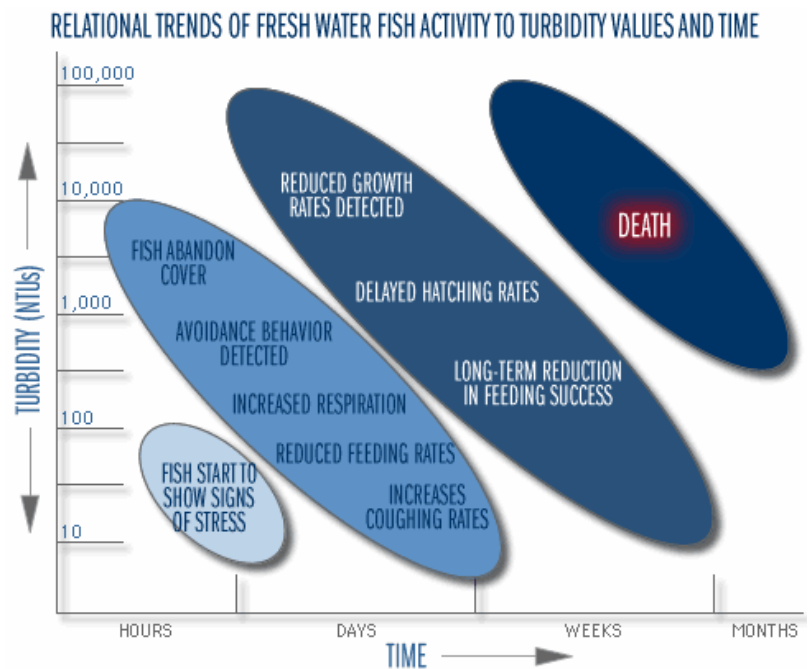
High turbidity was a prominent feature of almost every stretch of the Chippewa River in 2005. At all sites except Cottonwood Creek, Turbidity levels regularly were observed above the MN State Standard of 25 NTUs.

Sites where the turbidity level exceeds the standard (25 NTU) more than 10% of the time can be listed as impaired by the US Environmental Protection Agency. In 2005, only one of the Chippewa's sub-basins did not exceed the standard.

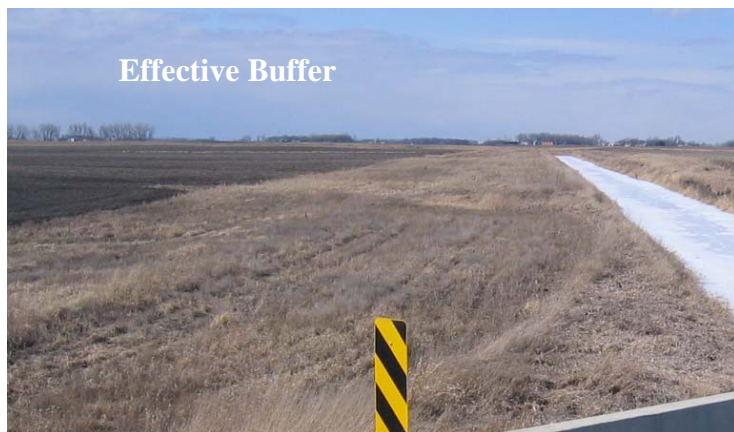
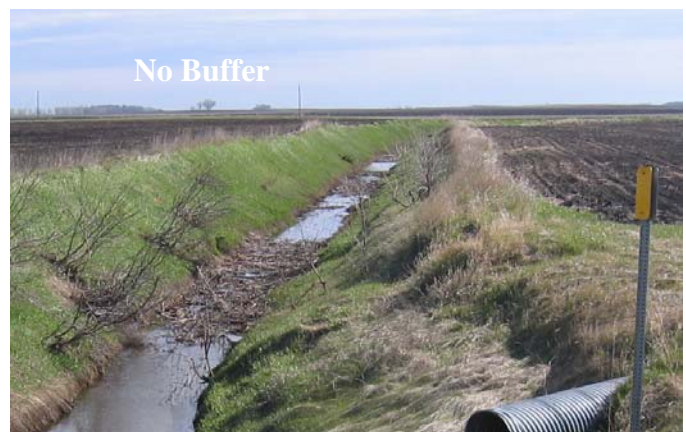
What is a Stream or Ditch Buffer?

The aquatic corridor, where land and water meet, deserves special protection in the form of buffers. A buffer can be placed along a stream, shoreline, or around a natural wetland. A buffer has many uses and benefits. Its primary use is to physically protect and separate a stream, lake, or wetland from future disturbance or encroachment. For streams, a network of buffers act as a right-of-way during floods and sustains the integrity of stream ecosystems and habitats.

Buffer extent and width tend to decrease as the river progresses downstream. Agricultural areas tend to have fewer and smaller buffers.

The Lower Mainstem, Dry Weather Creek, East Branch, and Shakopee Creek have over a quarter of their lengths Not protected by buffers. This need to be improved. These basins are prone to higher rates of erosion due to agricultural land use and bank erosion due to drainage modifications. Protecting the streams banks here is vital to the river health and to protecting adjacent fields from being lost to the river.

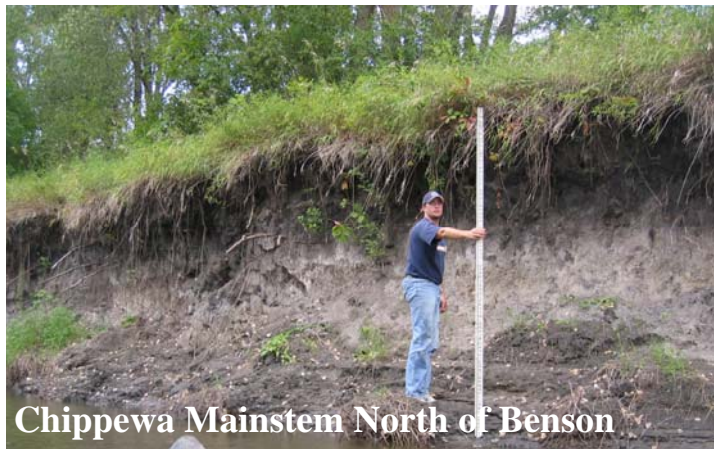
2005 marked the initiation of a new monitoring endeavor for the Chippewa River Watershed Project. Permanent cross section surveys were set up at each monitoring site. These surveys document the cross sectional profile of the river channel. By documenting the cross sectional profiles from year to year CRWP will be able to document changes to the channel dimensions caused by stream flow forces. In addition to the cross sectional profile CRWP paid special attention to the banks on each side of the channels surveyed. CRWP carefully documented the profile of the banks noting overhangs, undercuts and their

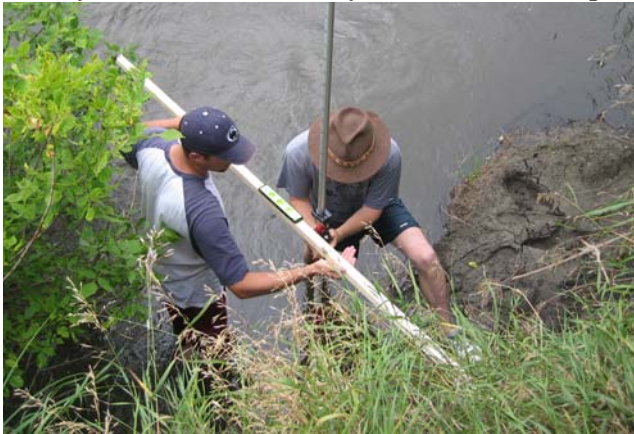
Site 18 Hwy 40 was the only site documented in 2004. Surveying in 2005 revealed alarming results. The banks receded by at least 2.42 feet. Bank pins, placed in 2003, corroborated the survey evidence. In 2004, only 18.6% of days had flows that were over the “normal high water level” and bank pins indicated only 3 inches of bank loss. In 2005, 87.4% of days had flows over the “normal high water level”. Therein lies the issue, flows above the “normal high water level” are the most responsible for shaping the river. If flows get above this level and their energy is not dissipated

appropriately they start to work against the banks and the river bottom. This is particularly true in entrenched channels which describes the Chippewa River at Hwy 40.
